**DRAFT REPORT
ROUND 7 DAM ASSESSMENT
ASSOCIATED ELECTRIC COOPERATIVE, INC.
NEW MADRID POWER PLANT
ASH POND 1 & 2 AND SLAG POND 1 & 2 IMPOUNDMENTS
NEW MADRID COUNTY, MISSOURI**

January 14, 2011

Re: Round 7 Dam Assessment - Draft Report
EPA Contract No. EP10W001313
Associated Electric Cooperative, Inc. New Madrid Power Plant
Ash Pond 1 and 2 Impoundments and Slag Pond 1 and 2 Impoundments
New Madrid County, Missouri

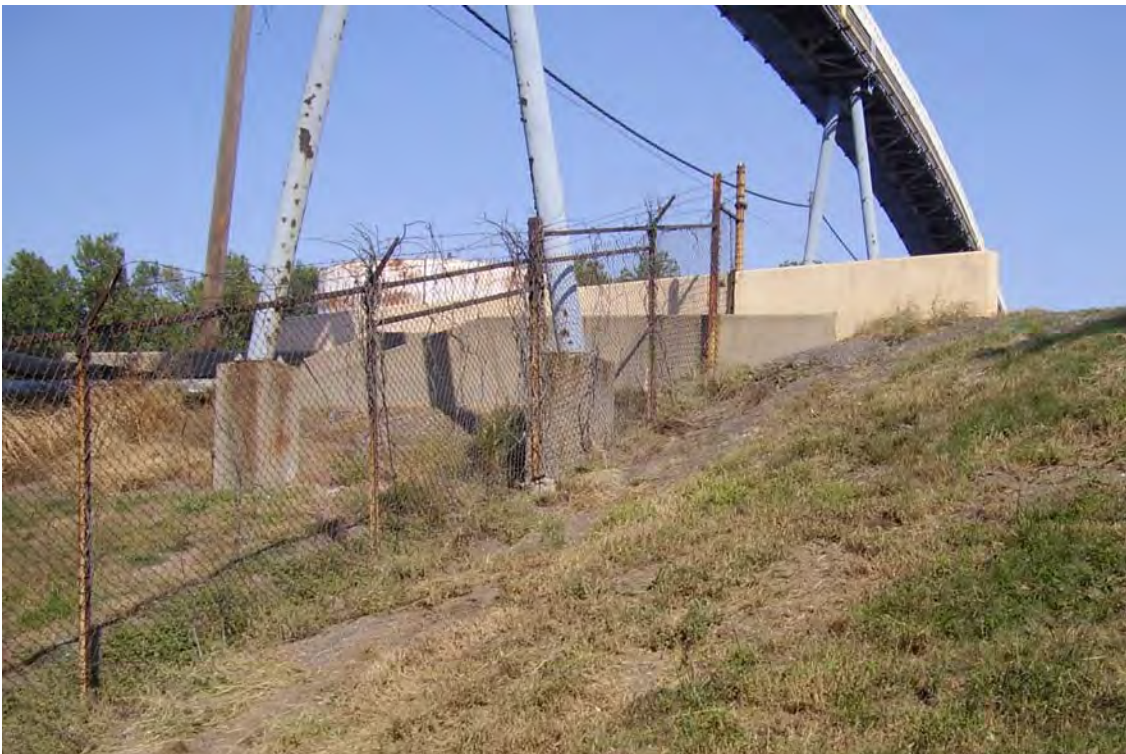
Client Name: U.S. EPA		Site Location: New Madrid Generating Facility Marston, Missouri	Project No. 01.0170142.20
Photo No. 57	Date: 10/6/10

Direction Photo Taken: East			
Description: Downstream slope of the AP1 showing erosion of the slope and crest near the road abutment.

1. Repair sloughed soil on the western embankment of the AP1 Impoundment.
2. Repair areas of erosion on the AP1 Impoundment, SP1 Impoundment, AP2 Impoundment, and SP2 Impoundment.
3. Repair rutting present on the SP2 Impoundment crest access road.

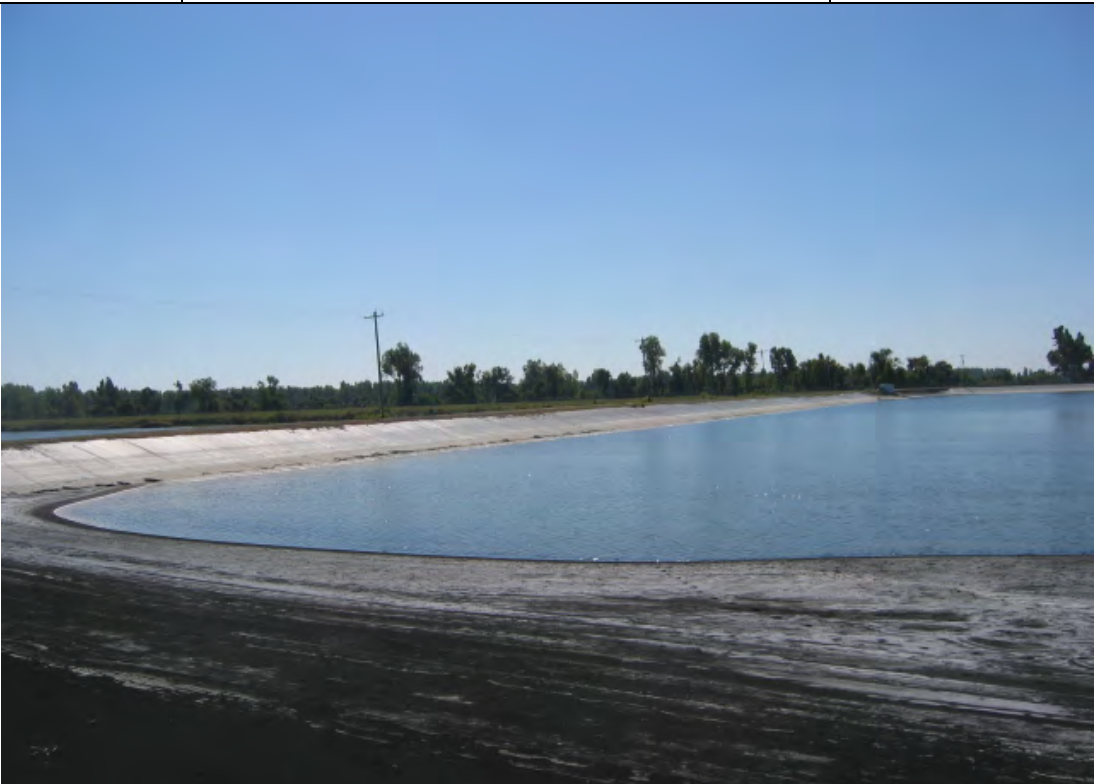
Client Name: U.S. EPA		Site Location: New Madrid Generating Facility Marston, Missouri	Project No. 01.0170142.20
Photo No. 61	Date: 10/6/10

Direction Photo Taken: Southeast			
Description: Upstream slope of the AP2.

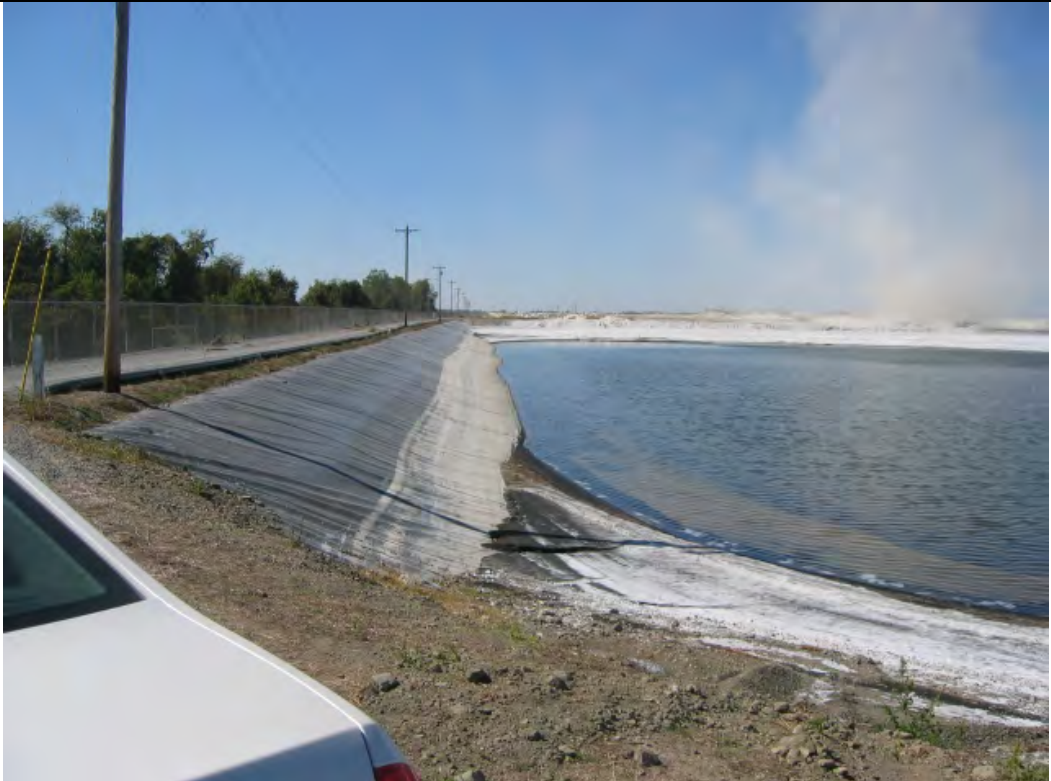
Client Name: U.S. EPA		Site Location: New Madrid Generating Facility Marston, Missouri	Project No. 01.0170142.20
Photo No. 63	Date: 10/6/10

Direction Photo Taken: West			
Description: Upstream slope of the AP2.

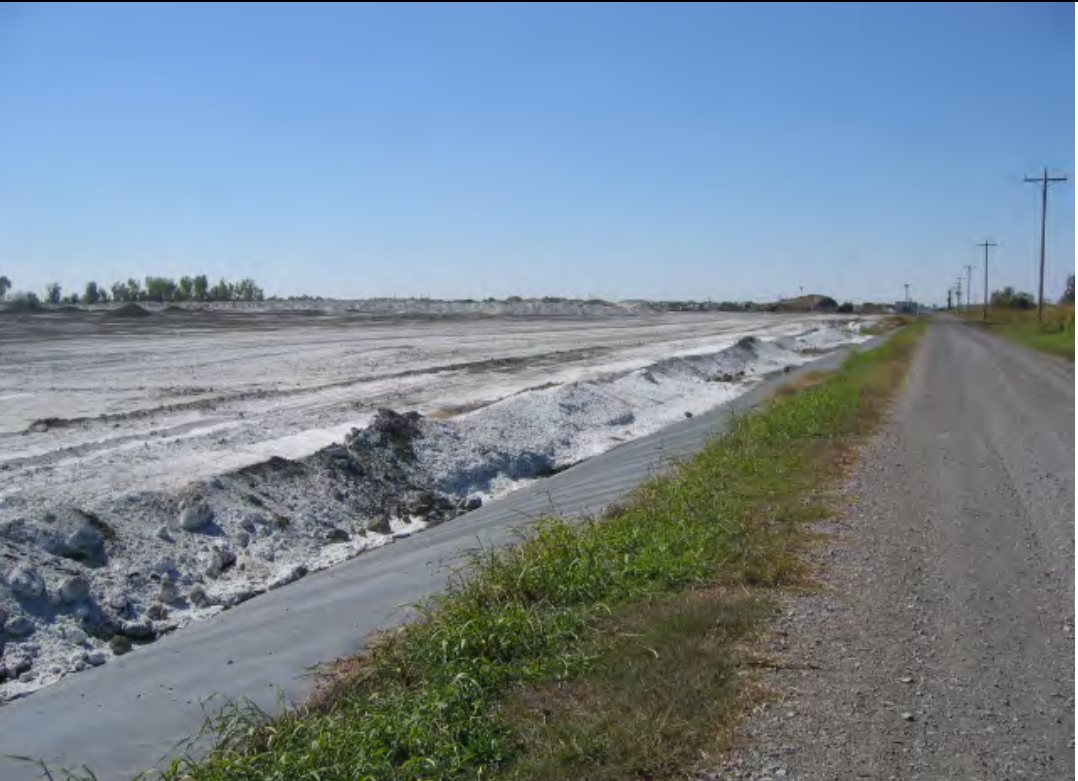
Client Name: U.S. EPA		Site Location: New Madrid Generating Facility Marston, Missouri	Project No. 01.0170142.20
Photo No. 65	Date: 10/6/10

Direction Photo Taken: West			
Description: Upstream slope and crest of the AP2.

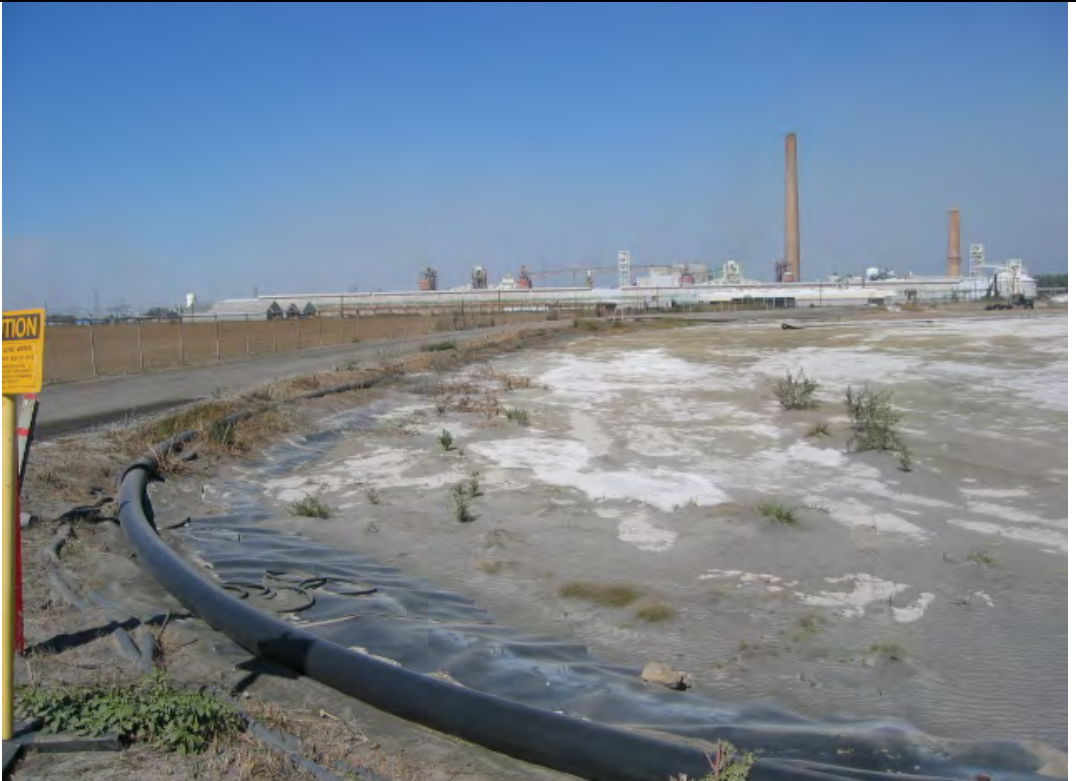
Client Name: U.S. EPA		Site Location: New Madrid Generating Facility Marston, Missouri	Project No. 01.0170142.20
Photo No. 67	Date: 10/6/10

Direction Photo Taken: Northwest			
Description: Upstream slope of the AP2.

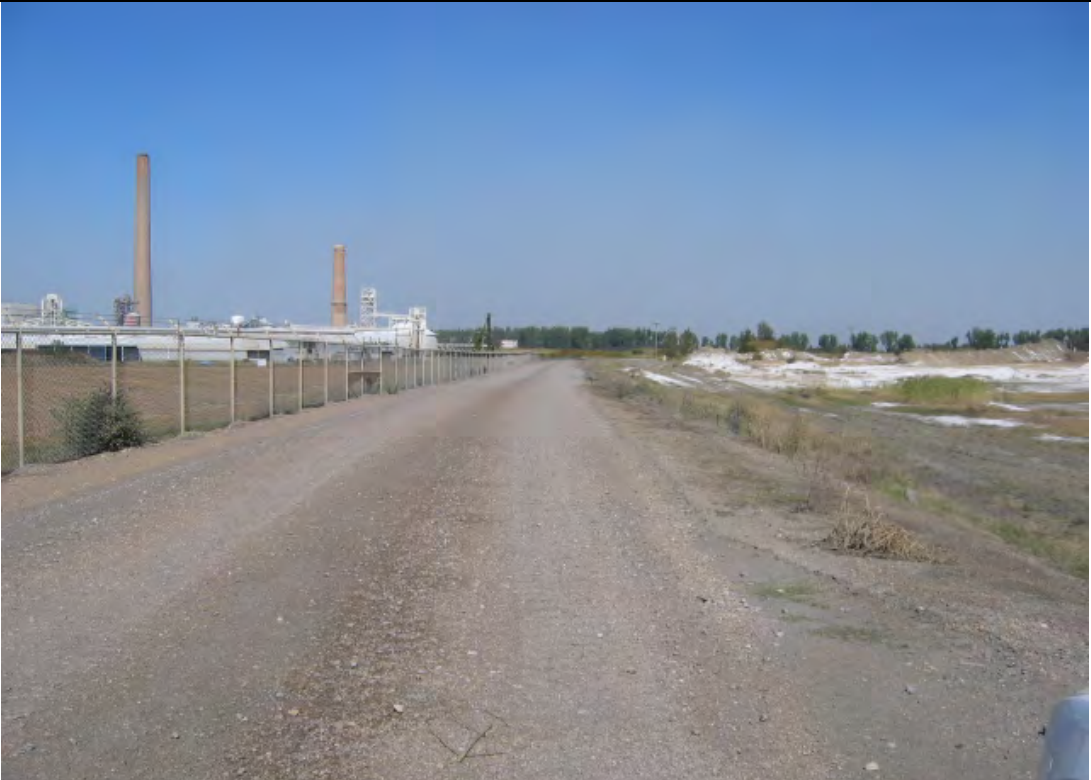
Client Name: U.S. EPA		Site Location: New Madrid Generating Facility Marston, Missouri	Project No. 01.0170142.20
Photo No. 69	Date: 10/6/10

Direction Photo Taken: Northeast			
Description: Upstream slope and crest of AP2.

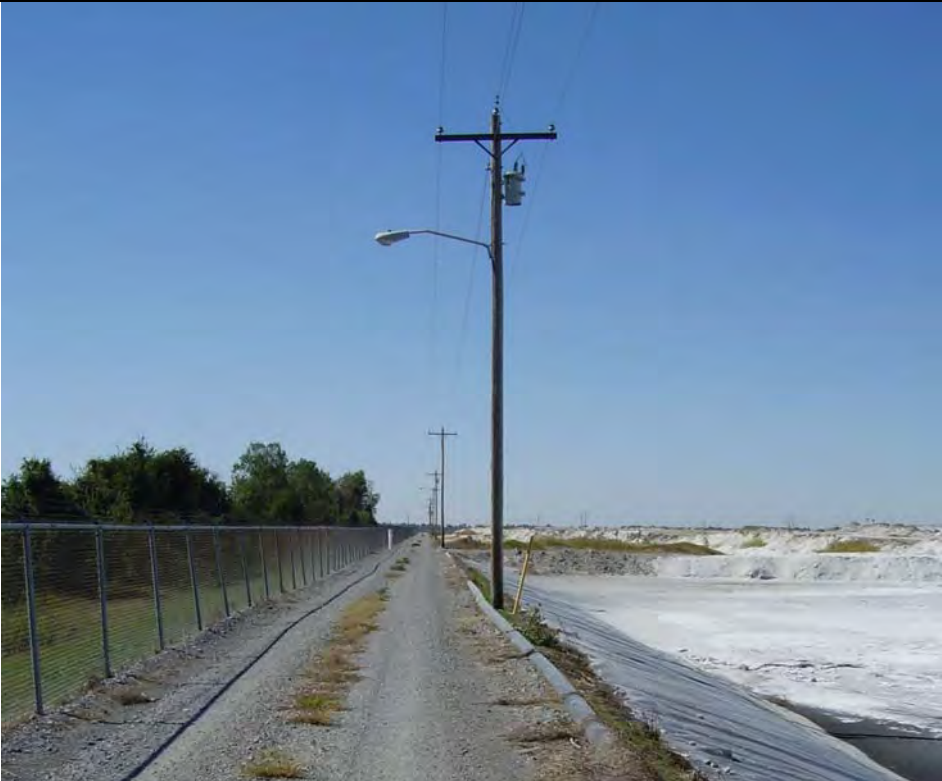
Client Name: U.S. EPA		Site Location: New Madrid Generating Facility Marston, Missouri	Project No. 01.0170142.20
Photo No. 71	Date: 10/6/10

Direction Photo Taken: West			
Description: Crest of the AP2.

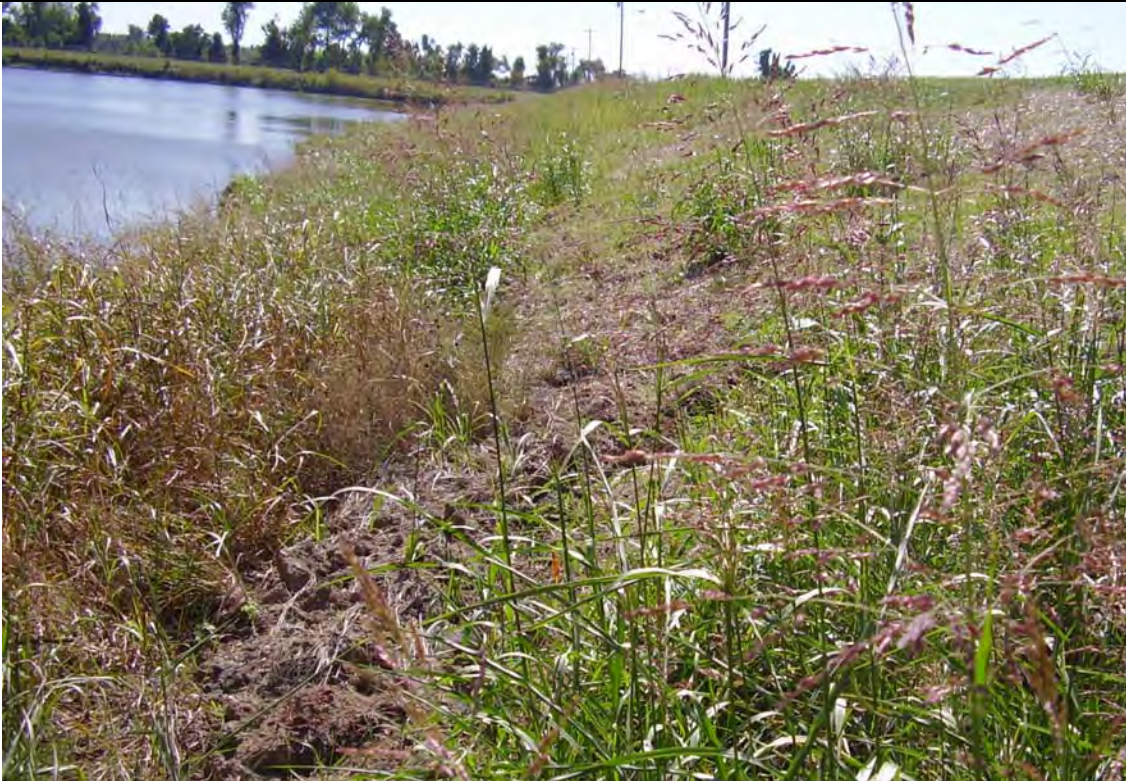
Client Name: U.S. EPA		Site Location: New Madrid Generating Facility Marston, Missouri	Project No. 01.0170142.20
Photo No. 75	Date: 10/6/10

Direction Photo Taken: South			
Description: Rutting of the downstream slope due to equipment.

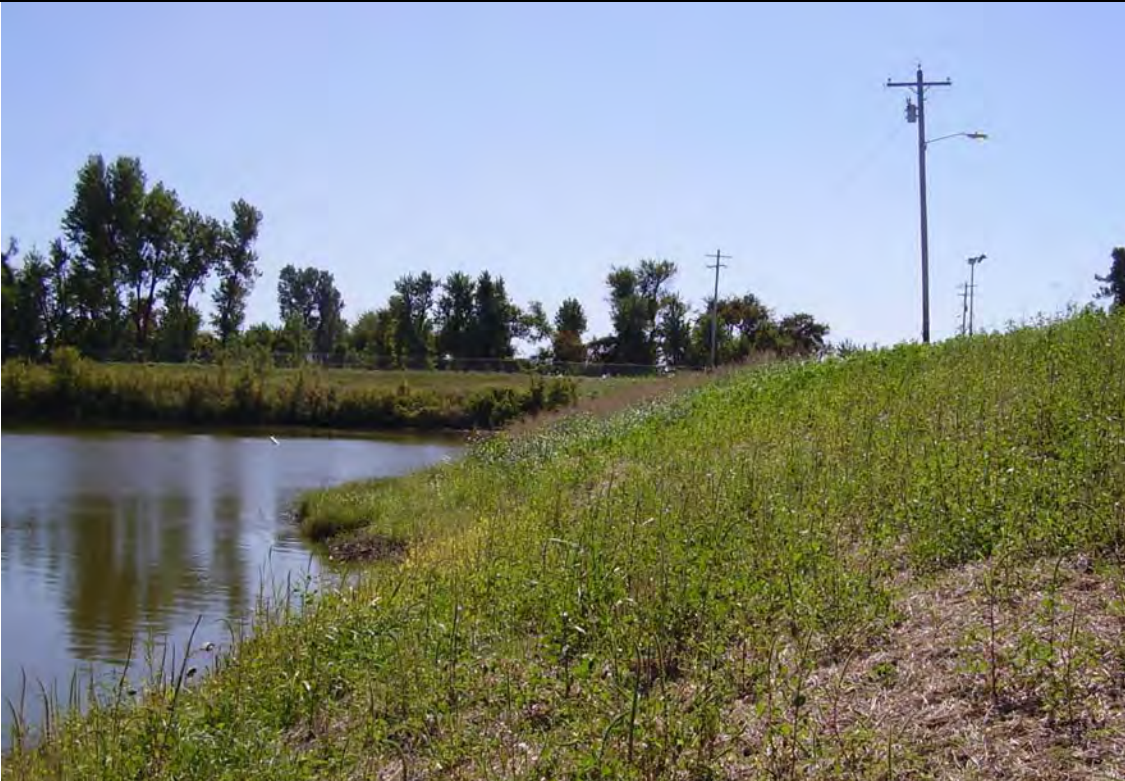
Client Name: U.S. EPA		Site Location: New Madrid Generating Facility Marston, Missouri	Project No. 01.0170142.20
Photo No. 77	Date: 10/6/10

Direction Photo Taken: South			
Description: Downstream slope of the AP2 showing sparse vegetation typical of the slope.

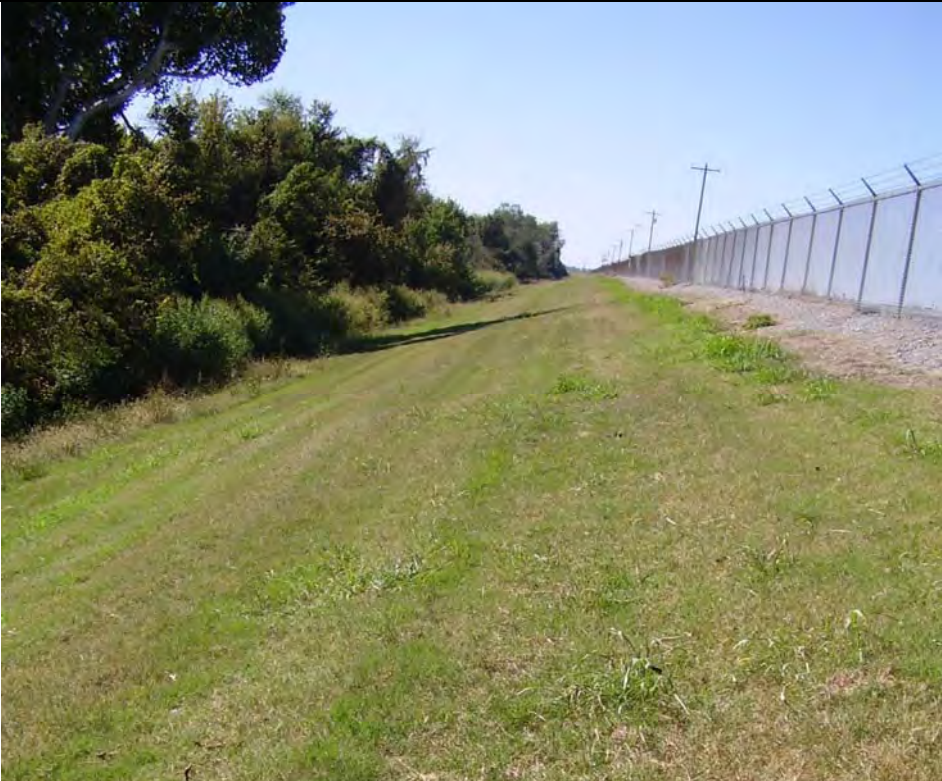
Client Name: U.S. EPA		Site Location: New Madrid Generating Facility Marston, Missouri	Project No. 01.0170142.20
Photo No. 79	Date: 10/6/10

Direction Photo Taken: West			
Description: Downstream slope of the AP2.

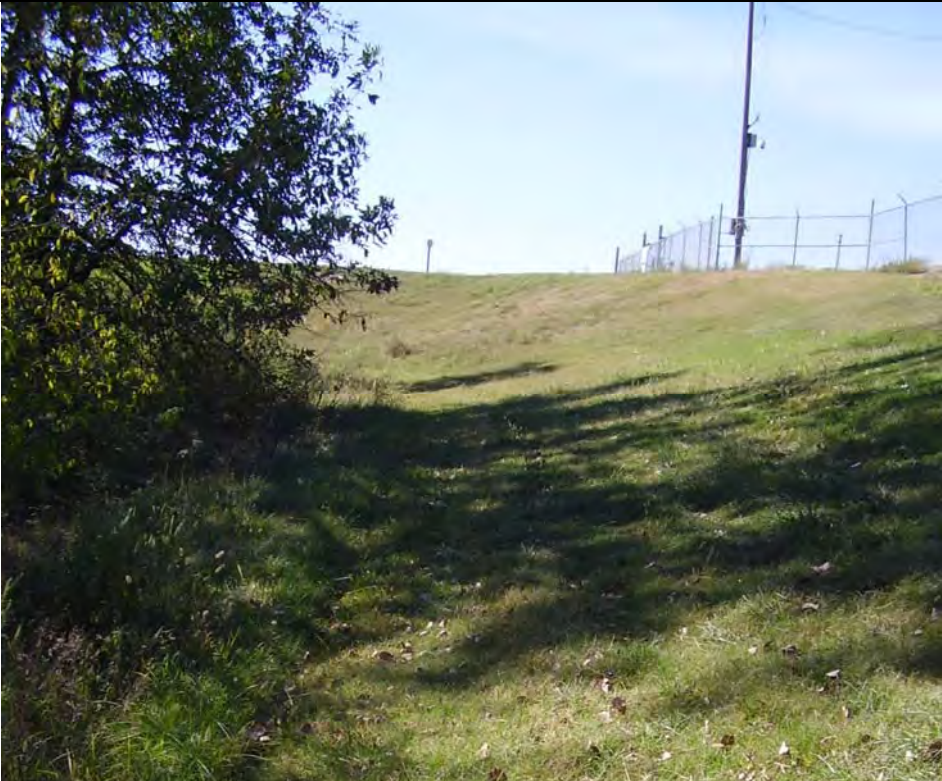
Client Name: U.S. EPA		Site Location: New Madrid Generating Facility Marston, Missouri	Project No. 01.0170142.20
Photo No. 81	Date: 10/6/10

Direction Photo Taken: West			
Description: Downstream slope of the AP2.

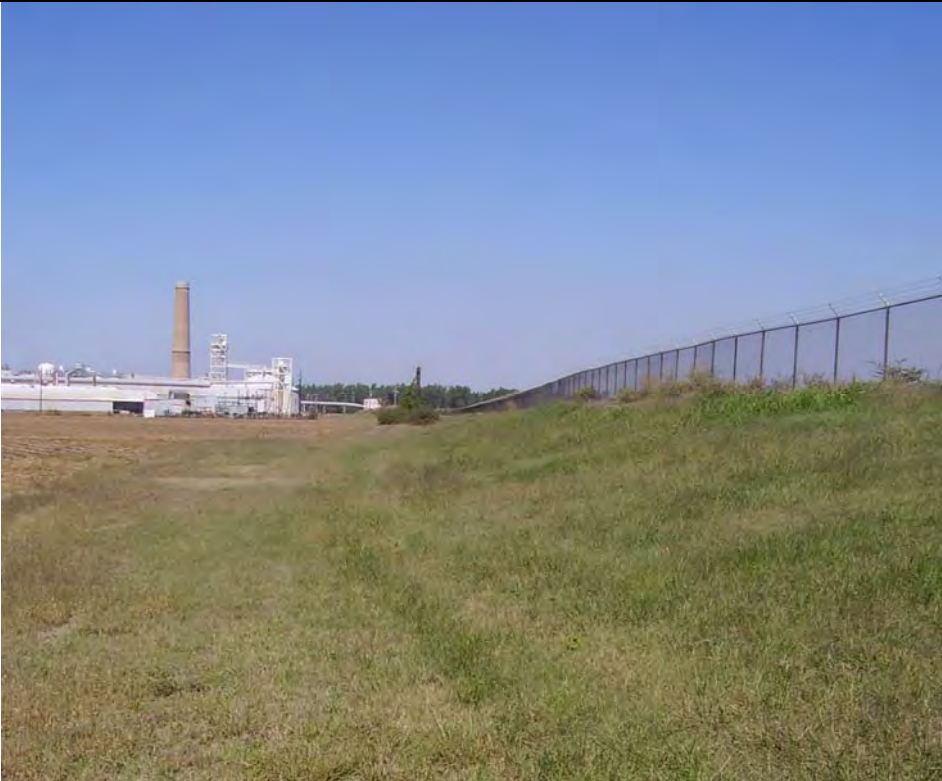
Client Name: U.S. EPA		Site Location: New Madrid Generating Facility Marston, Missouri		Project No. 01.0170142.20
Photo No. 83	Date: 10/6/10

Direction Photo Taken: Northeast				
Description: Downstream slope of the AP2.

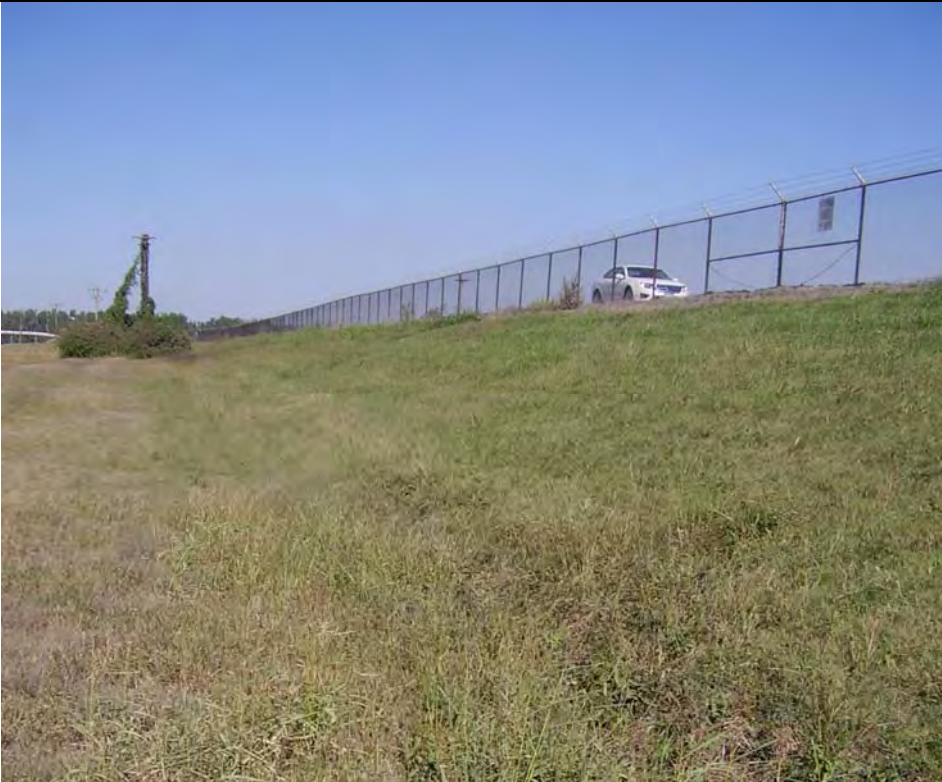
Client Name: U.S. EPA		Site Location: New Madrid Generating Facility Marston, Missouri	Project No. 01.0170142.20
Photo No. 85	Date: 10/6/10

Direction Photo Taken: Northeast			
Description: Downstream slope of the AP2 showing sloughing of the slope.

7. Evaluate the cause of sloughing on the western embankment of the AP1 Impoundment and SP2 Impoundment.
8. Evaluate the impact of toe removal on the stability of the western embankment of the SP2 Impoundment; repair if necessary.

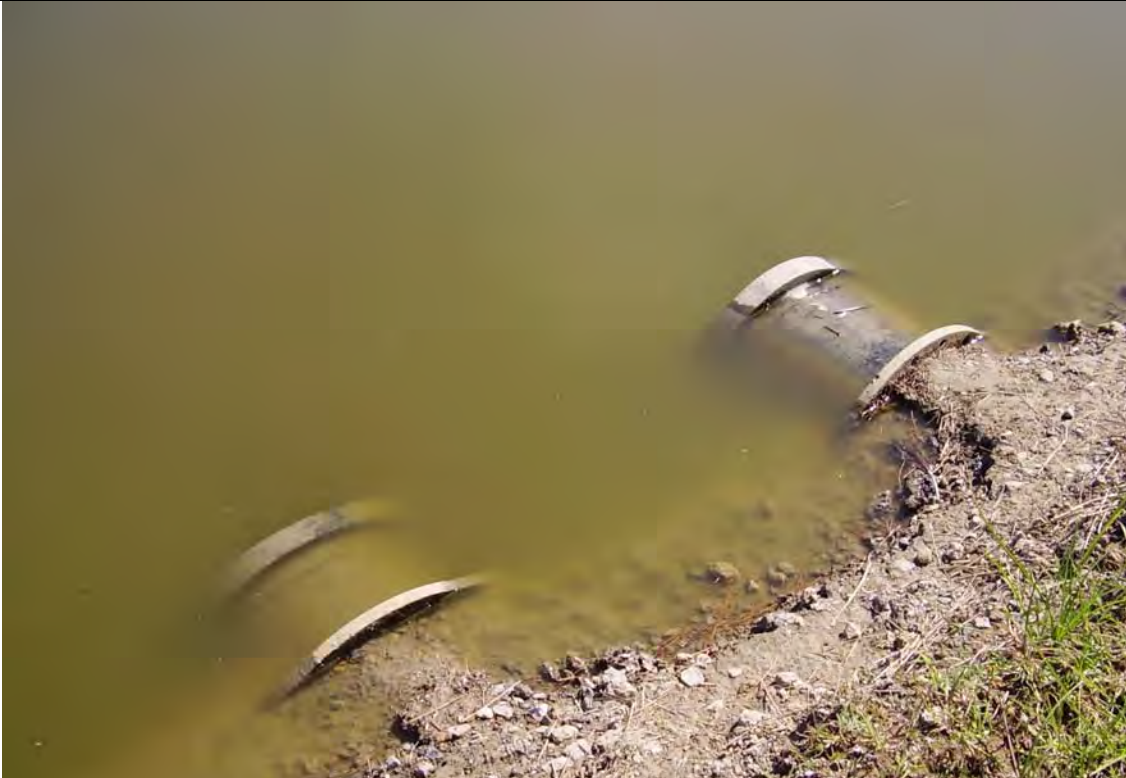
Photo No. 86	Date: 10/6/10

Direction Photo Taken: Southeast		
Description: Pipelines used to transfer water from the Make Up Water Pond to Ash Pond 2.
